**ABU GHRAIB DAIRY
ABU GHRAIB, IRAQ**

**SIGIR PA-09-172
JANUARY 14, 2010**

Summary of Report: PA-09-172

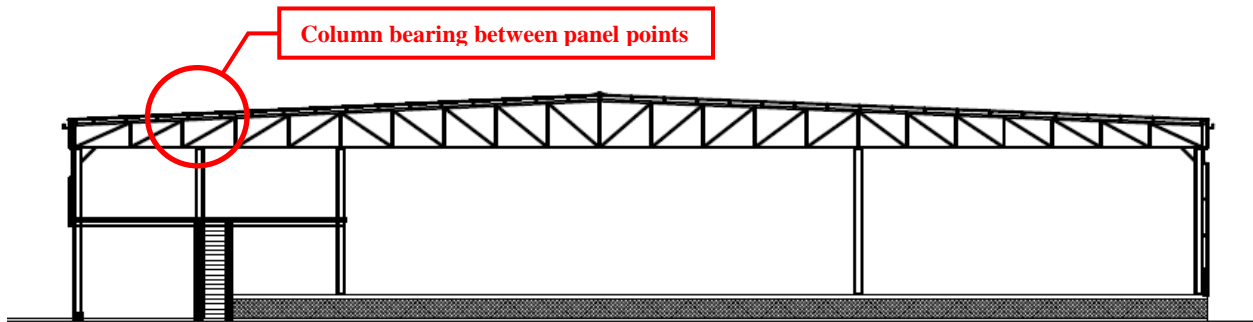
Figure 3. Truss configuration at mezzanine level

In the area of the mezzanine, the plans show additional columns (Figure 3), which extend through the mezzanine to the underside of the truss. The additional bearing locations provided by these columns are not at a truss panel point. The resulting reactions from these columns will introduce bending into the lower chord of the truss. SIGIR is

concerned that the members used in the lower chord of the truss are relatively light and do not appear to have the capacity to resist a significant amount of bending stress in addition to the compressive load that will result from the intermediate support.

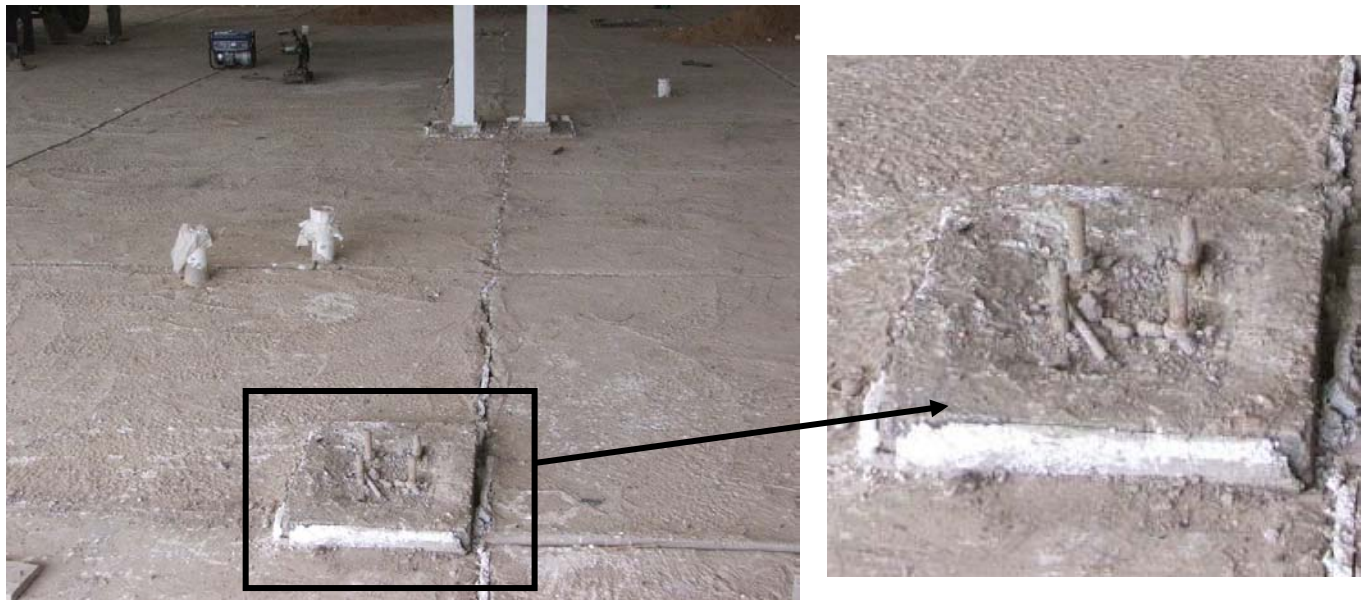
SIGIR noticed several sets of anchor bolts not attached to structural columns (Site Photo 2). The contractor's project manager stated that these anchor bolts are intended to attach the mezzanine columns to the foundation. It appears that the contractor did not adequately protect the anchor bolts during construction of the concrete slab, since SIGIR observed bolts coated with concrete and, in some cases, bolts that had been bent. These bolts may be damaged to the point that the mezzanine columns cannot be placed over the bolts without modification to the base plate or re-bending the bolts. The concrete-coated bolts require cleaning, and if the underlying threads are damaged, they may require re-threading to accept a nut to secure the base plate.

Site Photo 2. Unprotected, exposed anchor bolt group

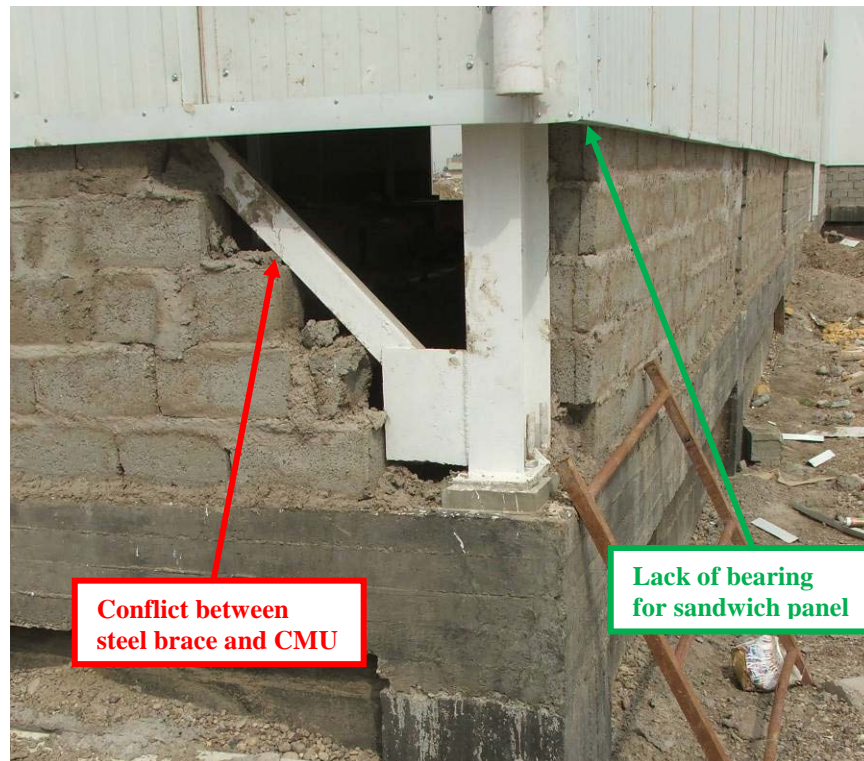
The CMU wall interferes with the steel cross bracing between several of the columns (Site Photo 4). It appears as if the contractor's solution to this issue was to lay the CMU wall around the bracing and coat the entire area with plaster. However, this approach may cause future problems as the steel bracing moves independently of the CMU wall causing recurrent cracking at the location.

Site Photo 4. Cross brace conflict with CMU perimeter wall

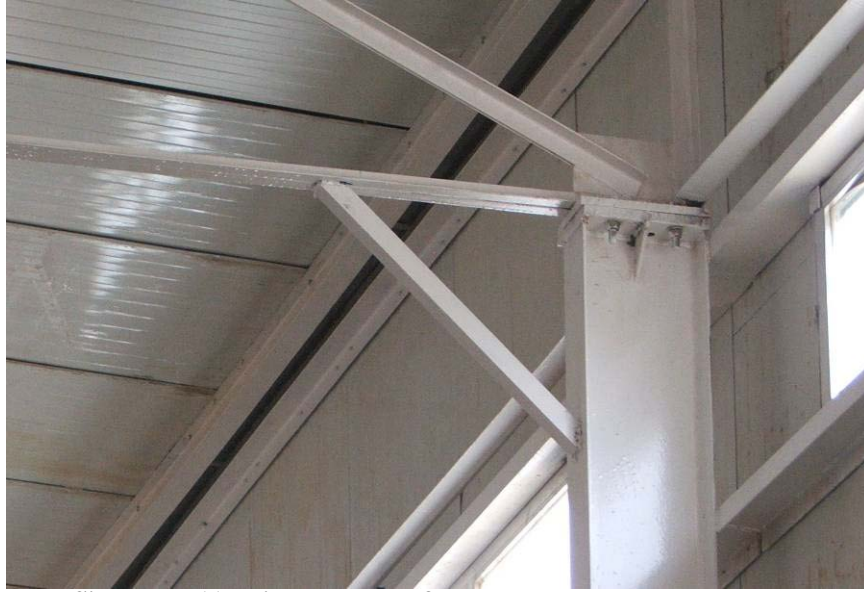
To provide lateral bracing parallel to the trusses, diagonal braces were welded to the steel columns and the lower chord of the truss (Site Photo 11). SIGIR observed what appeared to be significantly undersized braces in place, which could lead to excessive bending in the lower chord of the truss.

Site Photo 11. Diagonal brace from column to truss lower chord

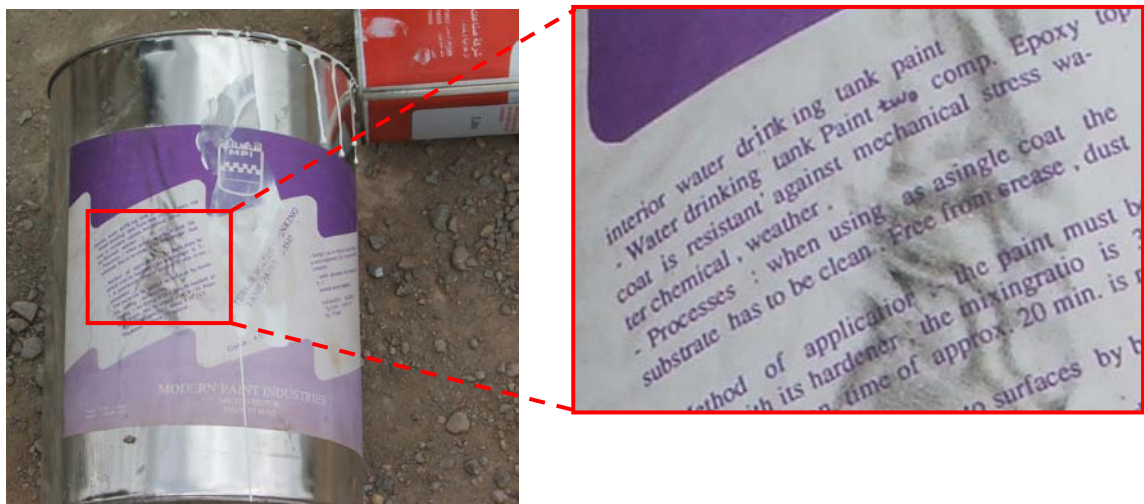
SIGIR observed the contractor applying coatings to a liquid tank’s interior. The labels on the coating containers (Site Photo 15) stated that the coatings were two-part epoxy and the material was compatible for use with potable water.

Site Photo 15. Coating for potable water tank

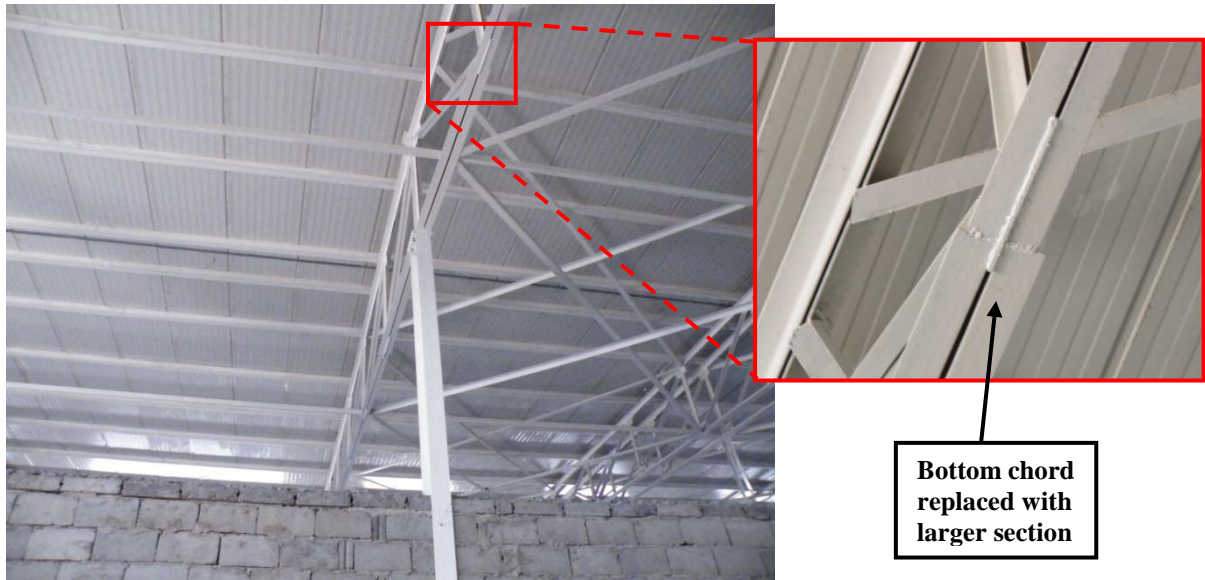
Site Photo 18. Contractor's truss modification

it was inadequate and replaced it with a larger section. Aerial lift capabilities were not available at the time of the site visit; therefore, a hands-on inspection of the repair could not be made. However, SIGIR was able to verify that the trusses had a larger bottom chord section in the areas previously noted as deficient (Site Photo 18).

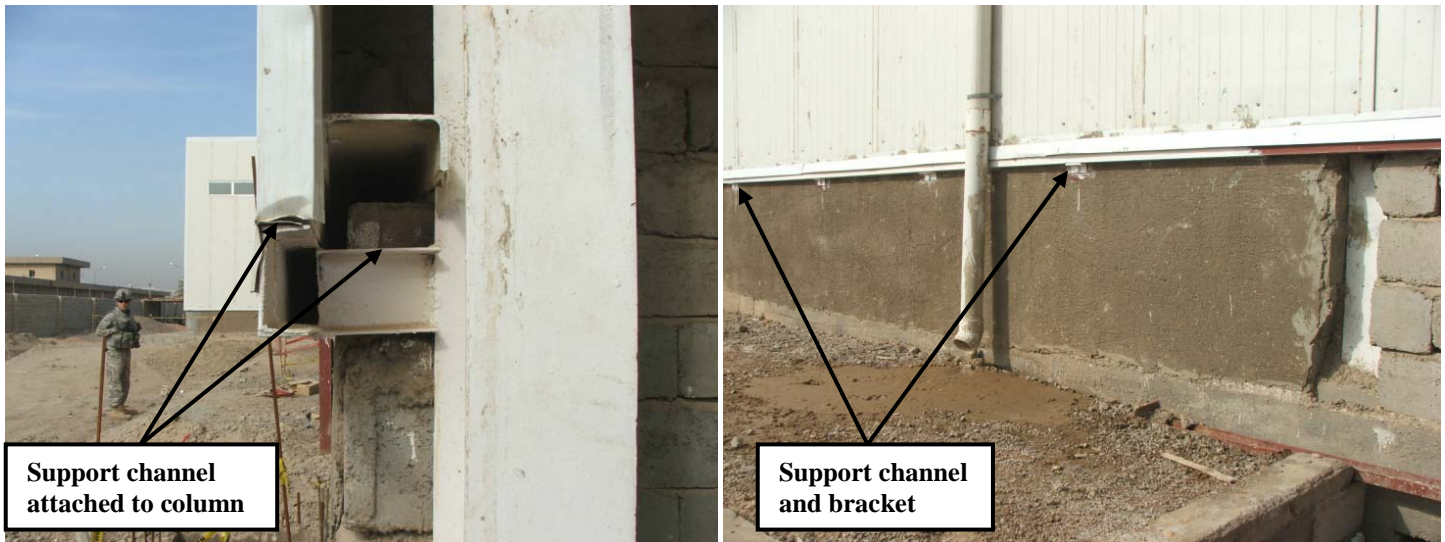
Another previously noted deficiency was the lack of support for the sandwich panels used as cladding for the building exterior. This lack of support was due to the contractor's deviation from the original design, which located the perimeter CMU wall to the interior of the steel framing. To remedy this situation, the contractor installed steel channels

Site Photos 21 and 22. Support channel for sandwich panel

around the perimeter of the building attached to the columns and supporting the panels (Site Photos 21 and 22).

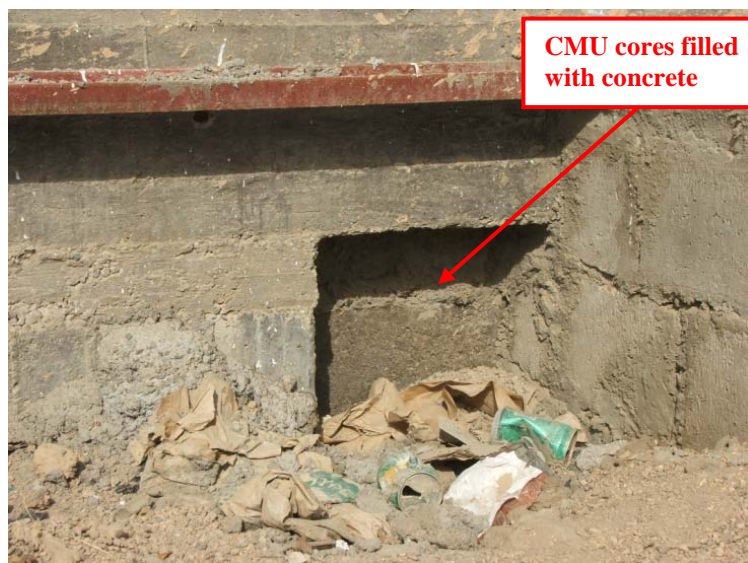
Site Photo 23. CMU cores filled with concrete

Initially, the contractor incorrectly placed CMUs with their sides' horizontal along the foundation wall. This orientation significantly weakened the CMUs. The contractor corrected this deficiency by using concrete to fill the cores of the CMUs, which provides increased strength to the wall (Site Photo 23).
